**Subject:** Sailplane Rigging – Procedures, Inspections and Training

This SIB revises EASA SIB 2019-07 dated 30 April 2019.

All sailplanes and powered sailplanes, subject to rigging.

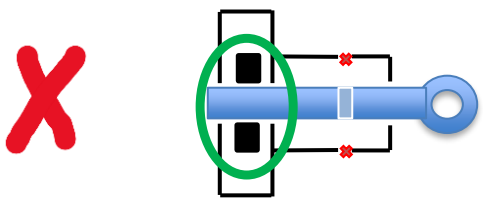
| Engaged but <u>not</u> secured. | The bolt moved away from its engaged position, and the control is unconnected. |

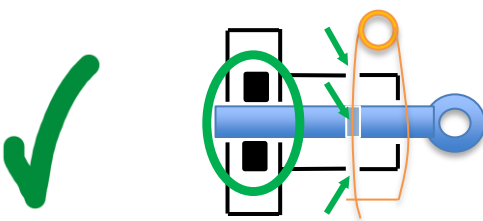
| | The Fokker-needle needs to be pushed through both holes of the cage and the hole of the bolt. |
| Engaged and secured. | |

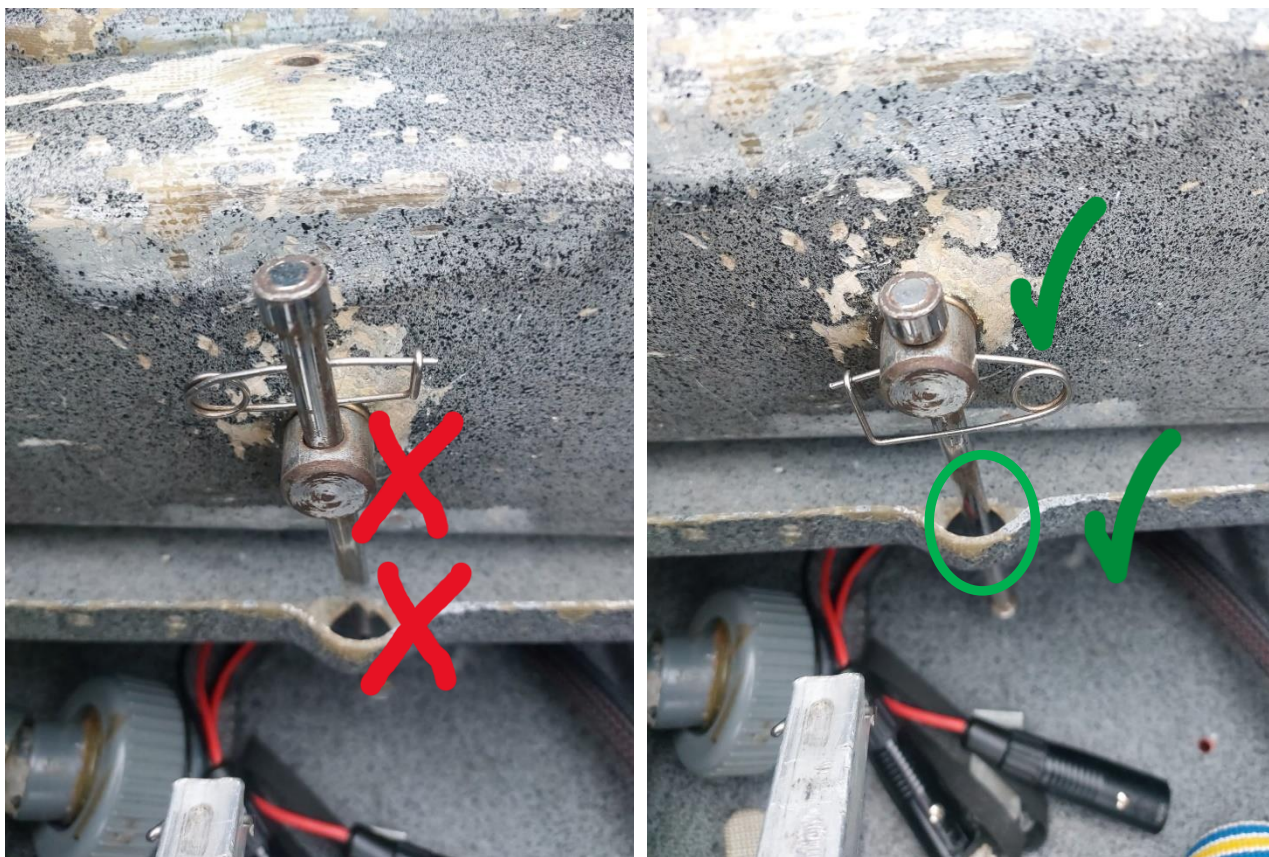
PIK 20

## Example of engage and secure of a main pin (wing connection)

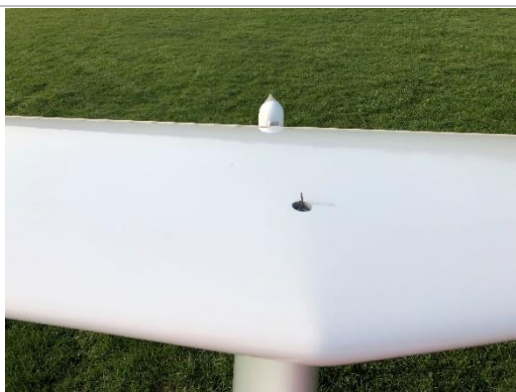
Installation of ASW 19 and later horizontal stabilizer. Screw need to be engaged and secured.

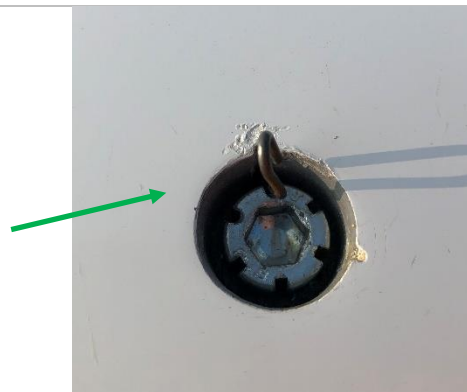
The bolt needs to be engaged and secured against rotation.

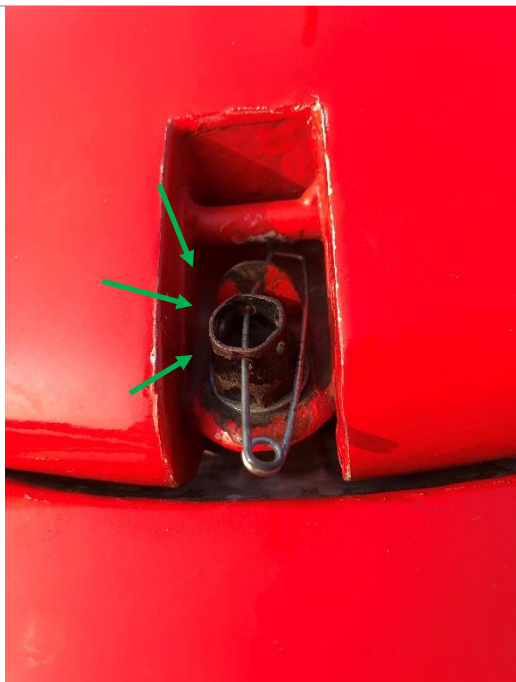
Installation of AS K-types horizontal stabilizer. The screw needs to be engaged and secured.

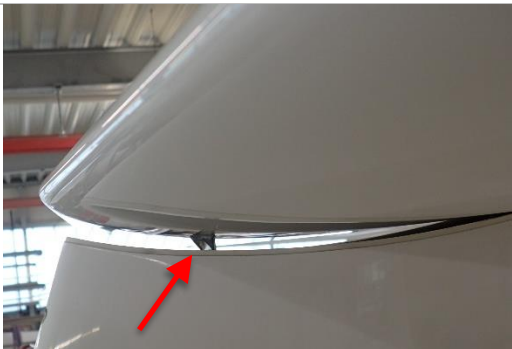
| | | Horizontal stabilizer engaged in its aft fitting but forward fitting not engaged. |

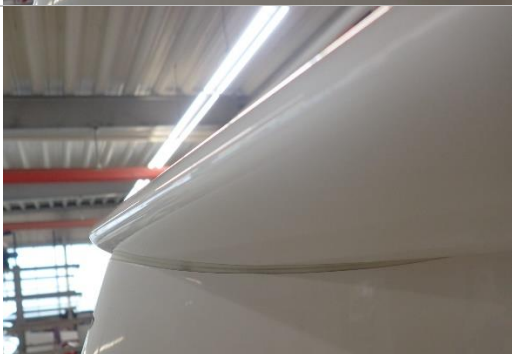
| | | Horizontal stabilizer properly engaged. |

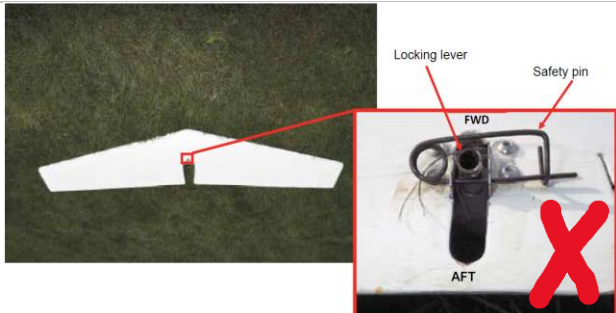
| | | Locking lever in the wrong – unlocked – position ( <i>on the wrong side</i> of the Safety Pin). |

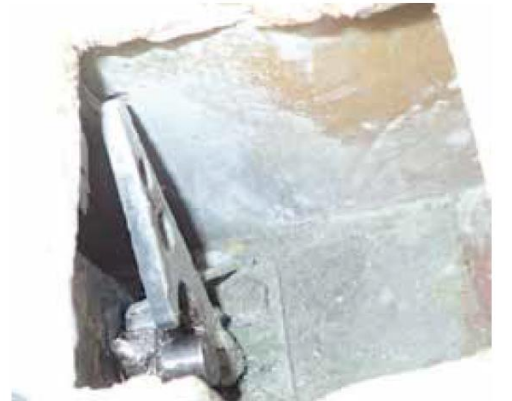
| | | In consequence, the locking hooks (left and right) are not engaged and the horizontal tailplane remains disconnected. |

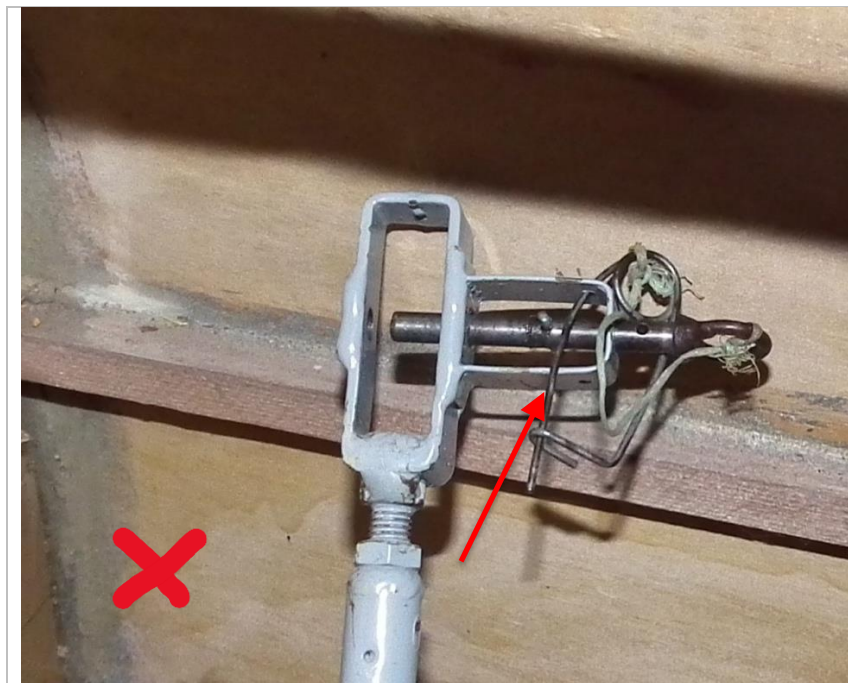
The example below shows an aileron connection, which is typical for old sailplanes with manual control connections. In this case, the connection was engaged during rigging, but not correctly secured. After three flights of short duration, the bolt moved away from its engaged position.

The connection was not secured. The Fokker-needle was put through one hole of the cage only, but not through the bolt and the lower hole of the cage, as well. In consequence, the bolt could move freely, and the control connection could become unconnected.

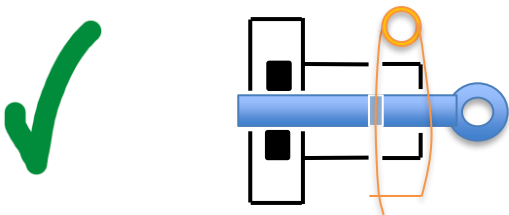
| | <p>The bolt is secured by pushing the Fokker-needle through <u>all three</u> holes.</p> |

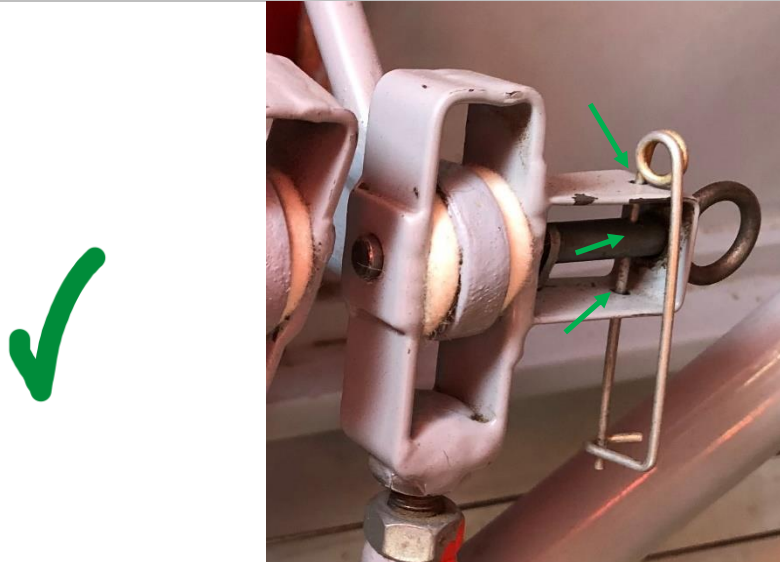
| | <p>A straight and not bent needle supports its proper application.</p> |

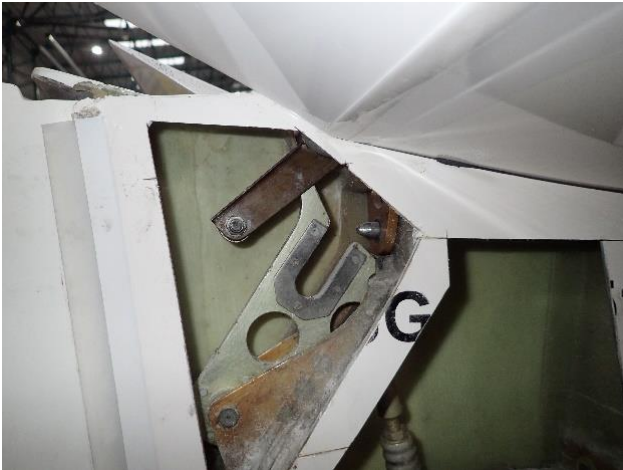
SZD / Allstar PZL Glider SZD-55-1

Similar designs can be found for the control connection of the elevator. Pictures below show examples of a mis-rigged vertical stabilizer, which led to a fatal accident. The mis-rigging had its root cause in an unauthorized and apparently unrecorded modification, to make rigging easier.

Disconnected elevator control

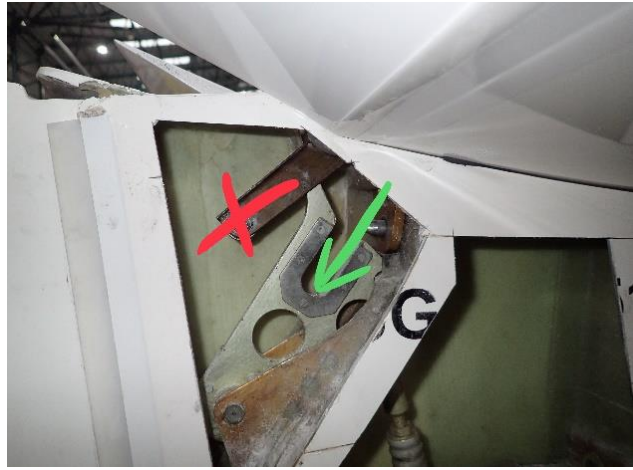
Disconnected elevator control

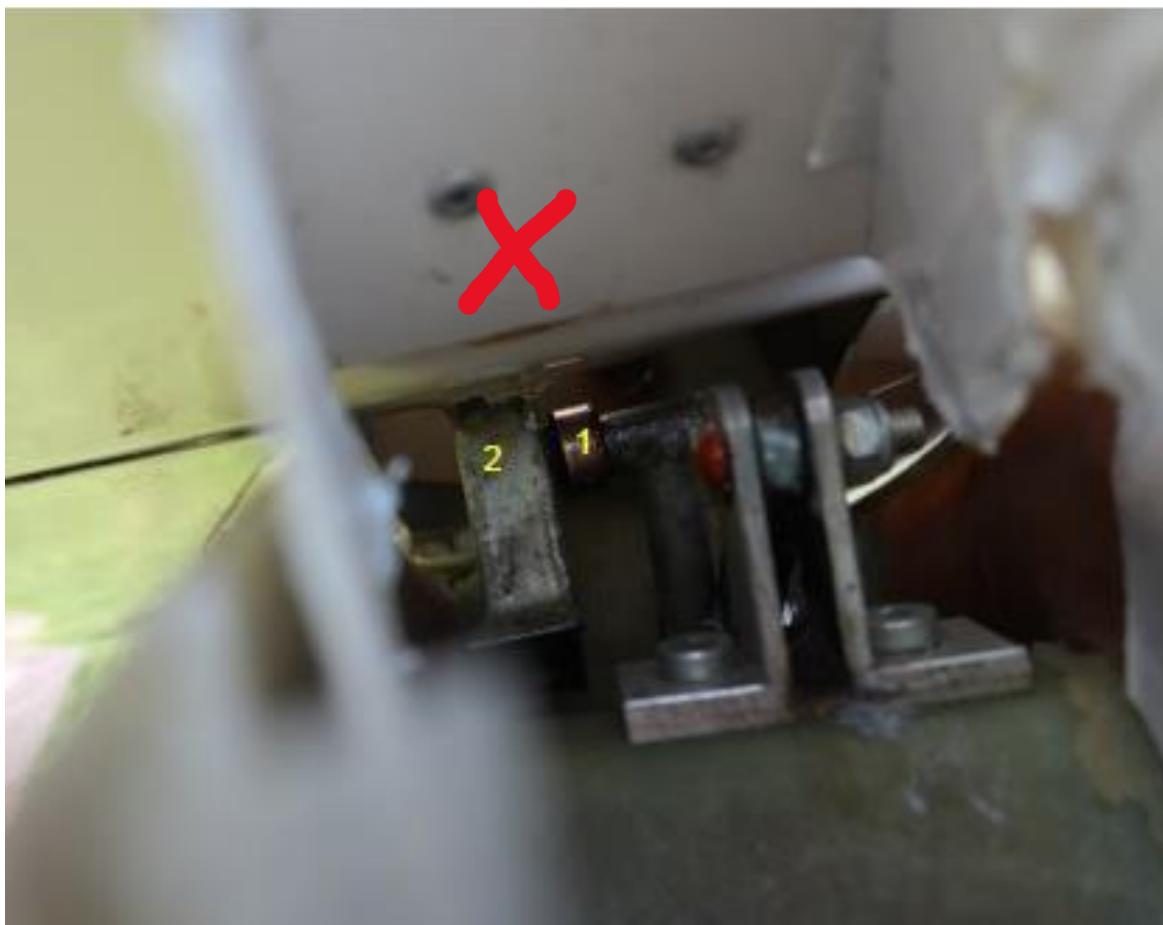
DG Aviation models

The roller at the fuselage side pushrod (1) is not inserted into the funnel (2) at the elevator

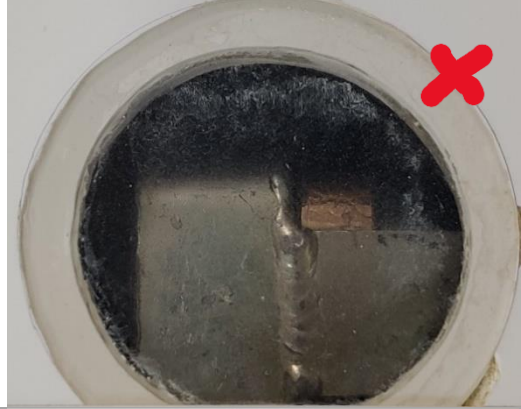
| | <p>Check for correct elevator connection by looking through the Plexiglas window at the upper surface of the stabilizer: Elevator control connection is not performed correctly, if the roller is visible.</p> |

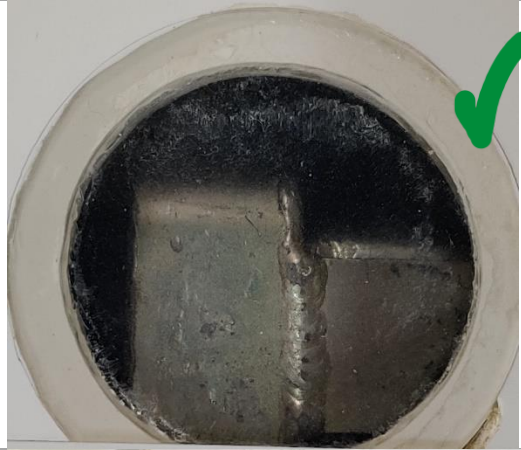
| | <p>Elevator control connection correct.</p> <p>For details refer to DG Aviation, Service Info No. 111/23</p> |

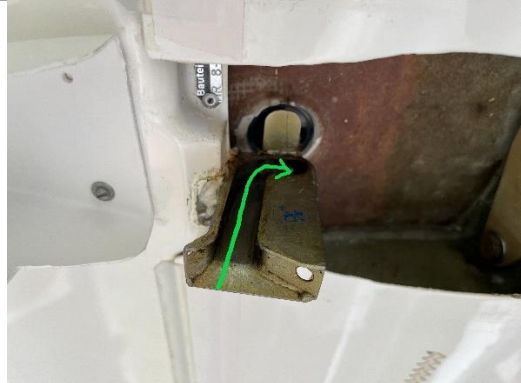
| | <p>The roller has to move into this funnel.</p> |

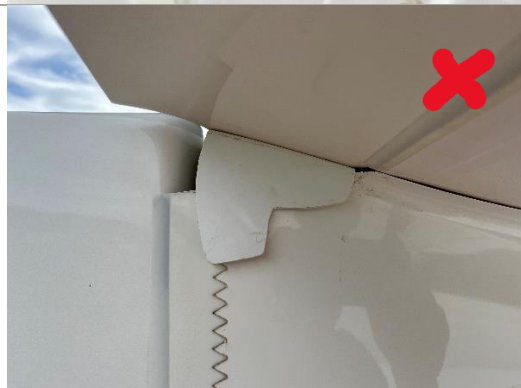
| | <p>Movement impaired by misplaced bracket. Roller most likely not in correct position.</p> |

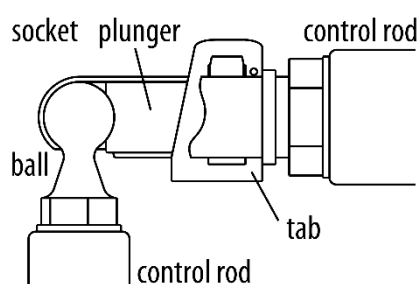
(a) Correct: cut-away shows how tab holds plunger in place

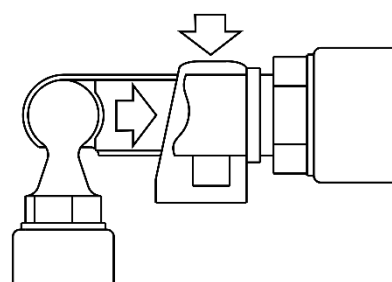
(b) Open: with tab depressed, plunger allows ball to be inserted or removed

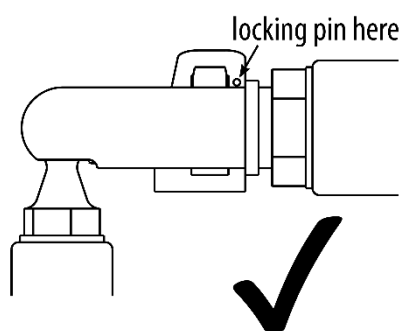
(c) Correct: ball engaged, locking pin may be inserted

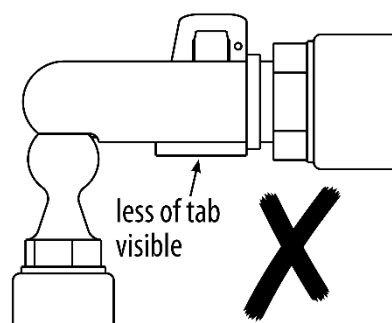
(d) Incorrect: ball not engaged, but locking pin may still be inserted

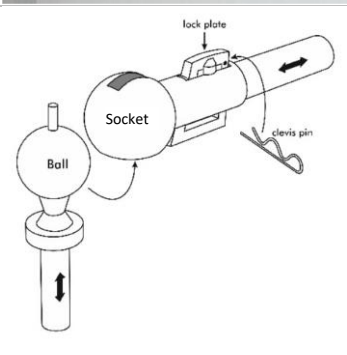
| | <p>Newer l'Hotellier connectors come with a pin on the top of the ball that becomes visible outside the socket, once the ball and socket are properly engaged. The pin allows also for a tactile inspection. The connection still needs to be secured.</p> <p>However, the pin on the top can cause the controls to move during the pre-takeoff check, falsely confirming a proper connection, even if the ball is not fully inserted and the socket is only resting on the ball with the pin.</p> |

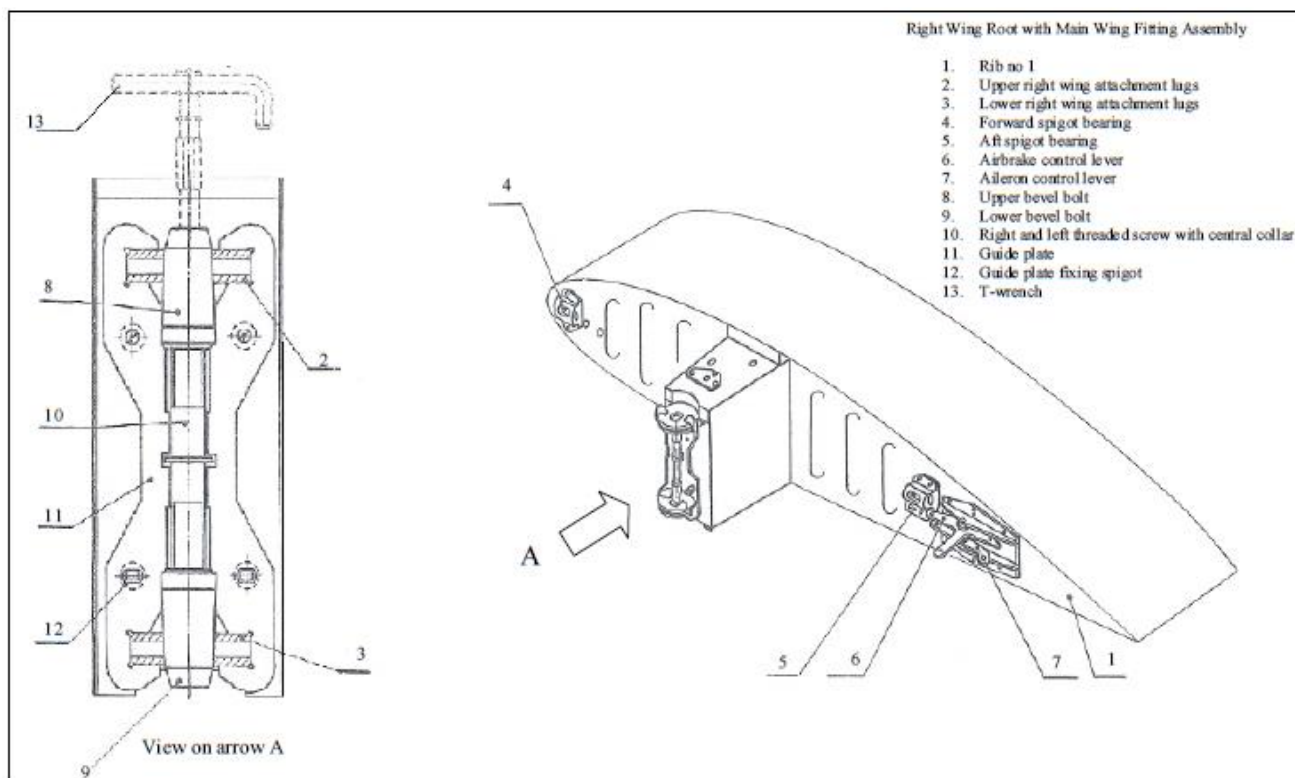
Example of an expanding main pin wing connection.

*In case of sailplanes with expanding main pin wing connections, practice rigging should be carried out under the supervision of someone who is familiar with the sailplane type.*
