BRAZILIAN EMERGENCY AIRWORTHINESS DIRECTIVE

EAD No: 2026-04-02

EAD No. 2026-04-02 - EMBRAER / 39-1602.

This Emergency Airworthiness Directive (EAD) applies to Embraer airplanes model EMB-545 and EMB-550, all serial numbers.

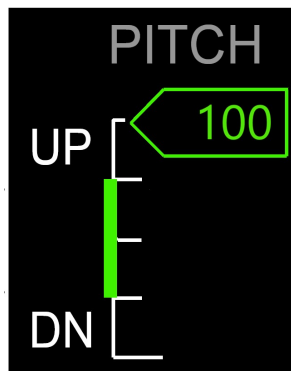
Figure 1 - Pitch trim indication.

(ii)(1) If the pitch trim indication stops before to reach the upper limit (full UP) (100) position or FLTCTRL HSTAB FAIL or FLTCTRL HSTAB FAULT message is displayed on Engine Indicating and Crew Alerting System (EICAS) of the airplane, it is prohibited to take-off the airplane. Report the failure to the applicable maintenance service and replace the PTA P/N 492600-1017 by another airworthy PTA with the same P/N, and perform a new OPC on the new PTA.

(ii)(2) If the full UP (100) position is reached and FLTCTRL HSTAB FAIL and FLTCTRL HSTAB FAULT messages are not displayed on airplane EICAS, accomplish with the requirements of paragraph **(a)(1)(i)** of this EAD within the next 50 FC or 75 FH after the pitch trim verification, whichever occurs first.
