### AIRWORTHINESS DIRECTIVE

**Number:** CAA-AD-10-001/2026

**Typ:** LG 425 „Šohaj 3“

### ATA 27-21 – FLIGHT CONTROLS – RUDDER – CONTROL CABLES

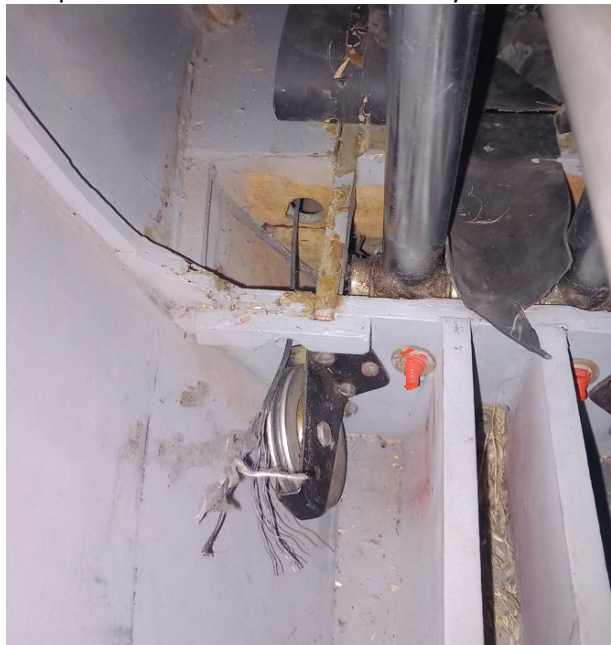
**Reason:** During flight, the rudder control cable fractured on one glider in service. The fracture occurred immediately downstream of the cable’s passage over the pulley mounted on the second bulkhead in the cockpit, beneath the floor, and just aft of the swaged eye attaching the cable to the rudder pedal. See *Fig. 1*. As a result, complete loss of directional control by means of the rudder pedals occurred.

*Fig.1 – Fractured rudder control cable*

1. Once, at the next annual inspection, but no later than 28 February 2027.
2. Thereafter, at 200-flight-hour intervals, starting from completion of the one-time inspection.

- A. The rudder control cables shall be inspected by a person listed in the certifying staff roster of a maintenance organisation that includes the LG 425 glider in the National Annex to its Maintenance Approval and who also holds an authorisation for the periodic extension of the Certificate of Airworthiness (PPKB) specifically for the LG 425 glider.
- B. Inspection procedure:
  1. **Remove:**
    - a. the forward fuselage cover;
    - b. the faux-leather cover at fuselage bulkhead No. 1;

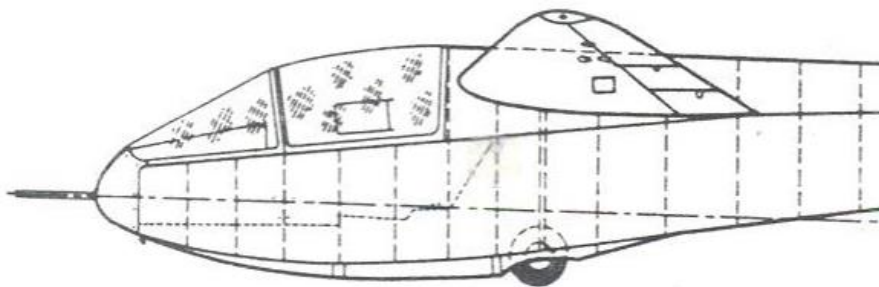
*Fig. 2 – LG 425 glider bulkhead arrangement*

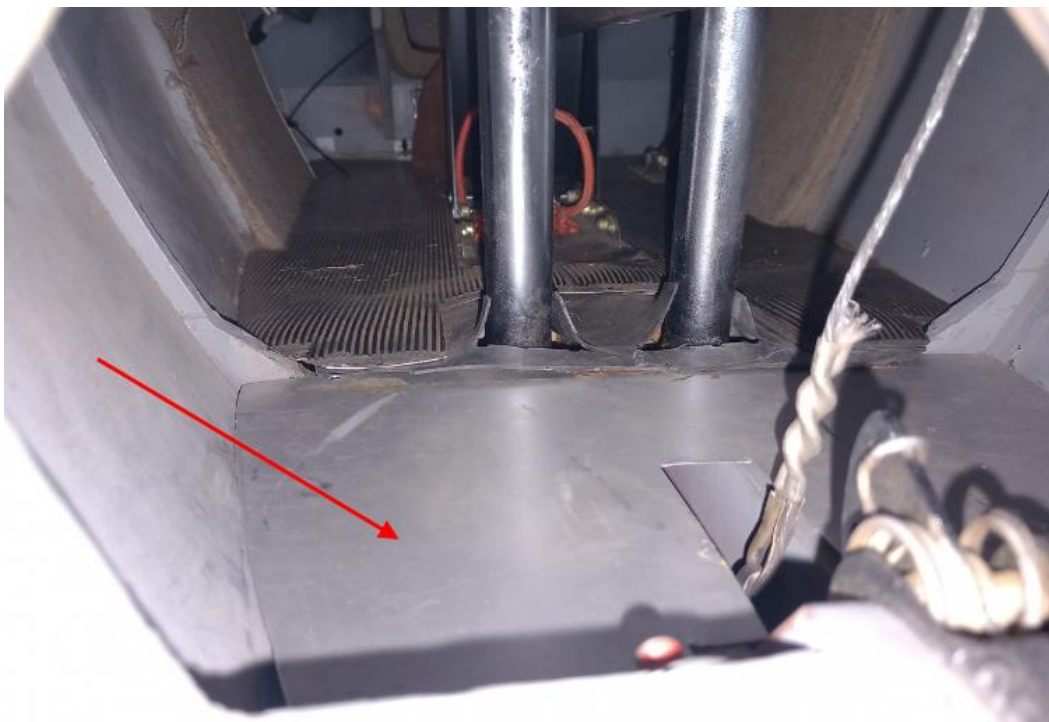
*Fig. 3 – Forward section of the cockpit floor*

- c. the forward section of the cockpit floor between bulkheads Nos. 1 and 2 (the section of floor forward of the rudder pedals);

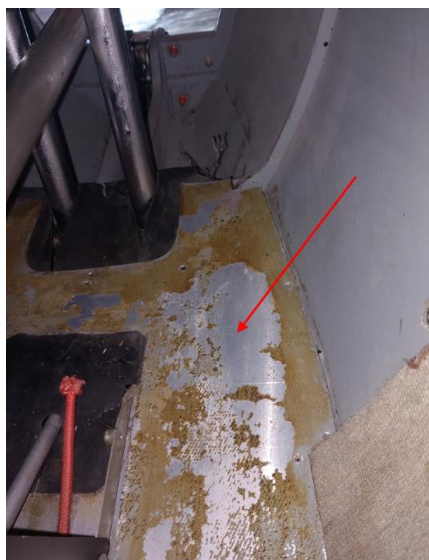
*Fig. 4 – Aft section of the cockpit floor*

- d. the aft section of the cockpit floor between bulkheads Nos. 2 and 3 (the section of floor aft of the rudder pedals);

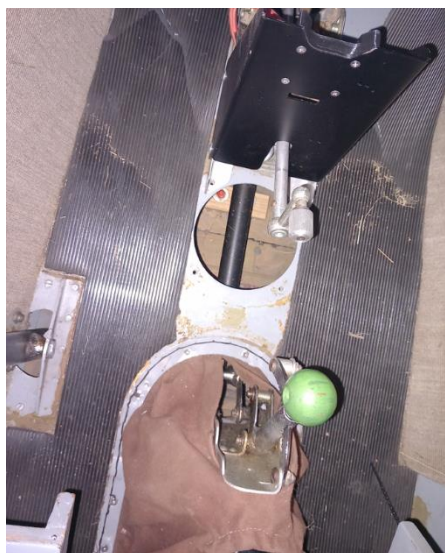
*Fig. 5 – Circular cover in the cockpit floor between bulkheads Nos. 3 and 4*

- e. the circular cover in the cockpit floor between bulkheads Nos. 3 and 4;

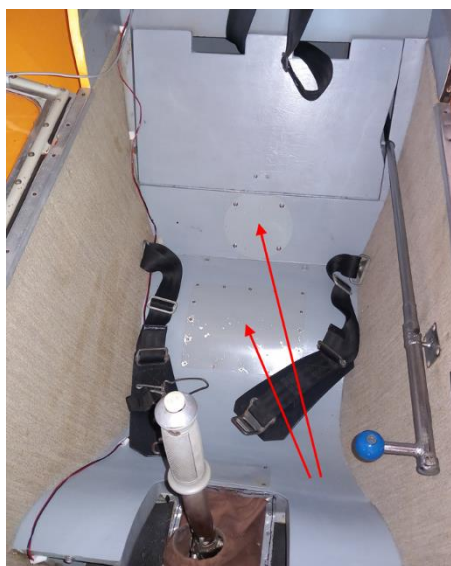
*Fig. 6 – Covers on the pilot's seat and backrest*

- f. the cover on the pilot's seat in the cockpit between bulkheads Nos. 6 and 7;
- g. the circular cover on the cockpit backrest

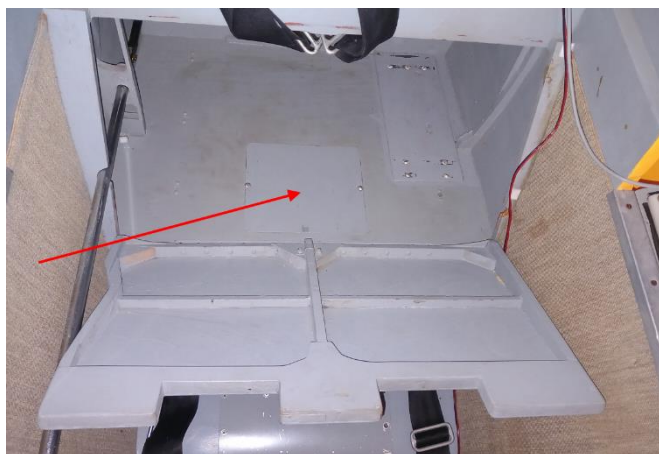
*Fig. 7 – Cover in the baggage compartment*

- h. the cover in the floor of the baggage compartment between bulkheads Nos. 7 and 8;

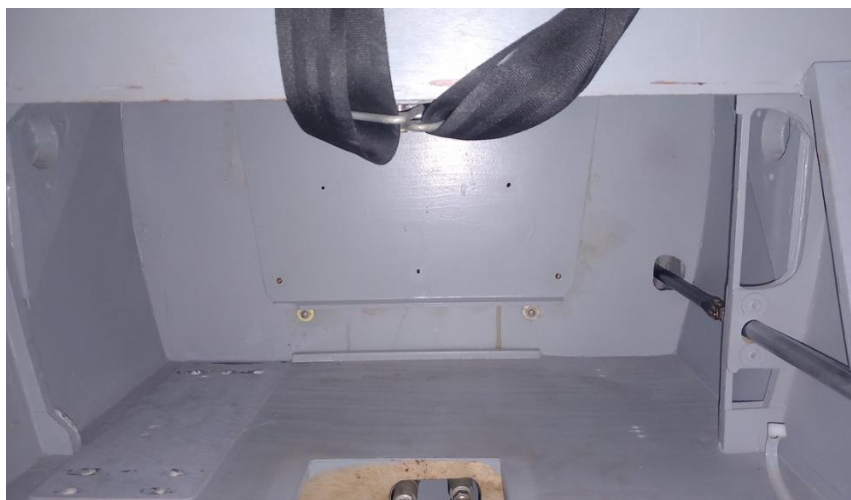
*Fig. 8 – Cover on bulkhead No. 9*

- i. the cover on bulkhead No. 9 in the baggage compartment;

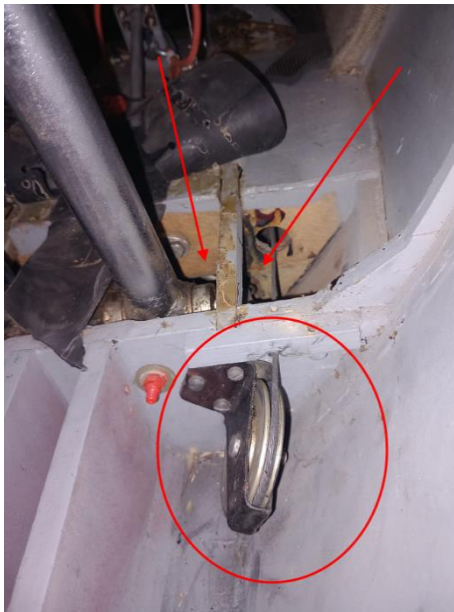
*Fig. 9 – Rudder pedal control pulley on bulkhead No. 2*

2. **Inspect the condition and attachment of the pulleys** and check that they rotate freely:
- a. on the forward side of bulkhead No. 2 (access from the nose of the fuselage);

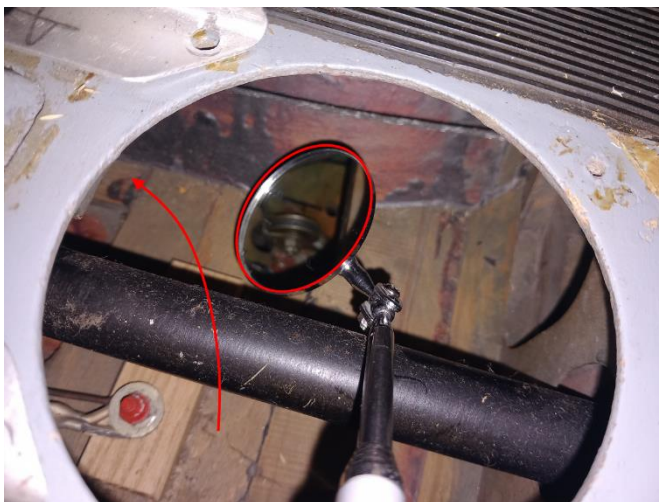
*Fig. 10 – Mirror view of the pulley aft of bulkhead No. 3*

- b. on the aft side of bulkhead No. 3 (access through the circular inspection opening in the cockpit floor between bulkheads Nos. 3 and 4);

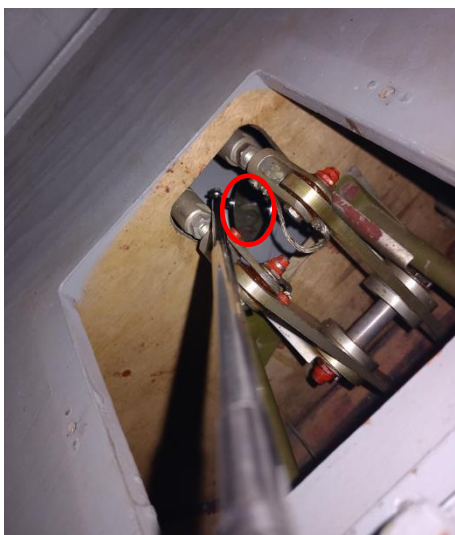
*Fig. 11 – Mirror view of the pulley aft of bulkhead No. 8*

- c. on the aft side of bulkhead No. 8 (access through the inspection opening in the baggage-compartment floor and then through the control-rod opening in bulkhead No. 8);

*Note 2: Because access to the pulleys at bulkheads Nos. 8 and 9 is limited, if in doubt, raise the glider, remove the landing gear wheel and wheel spat, and perform the inspection through the landing gear bay.*

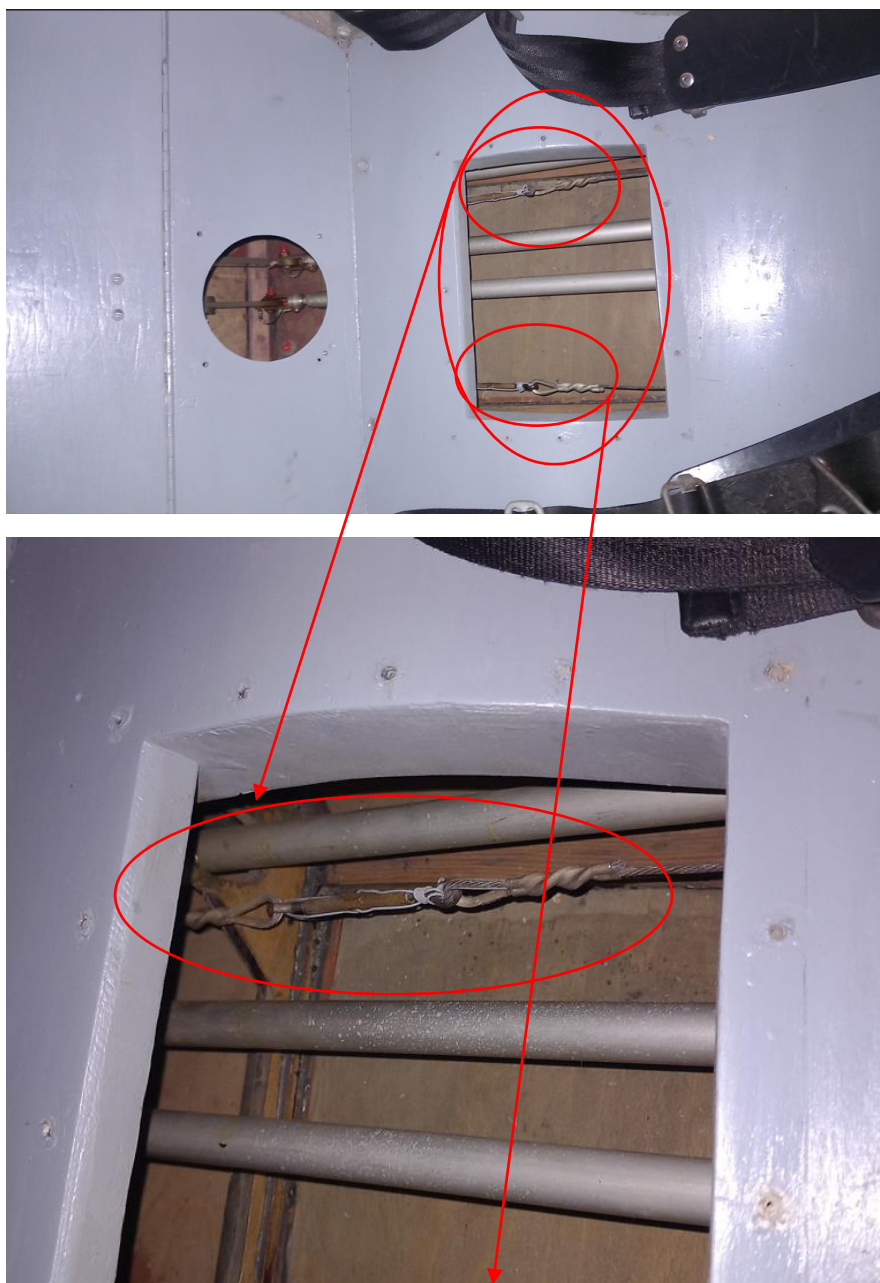
*Fig. 13 – Inspection areas aft of bulkhead No. 2, shown as examples of areas that must be inspected*

- b. the condition of the cables over a length of at least 30 mm from the swaged cable ends;
- c. the areas around the turnbuckles between bulkheads Nos. 6 and 8;

*Note 1: No broken or protruding wire strands may be present in these critical areas.*

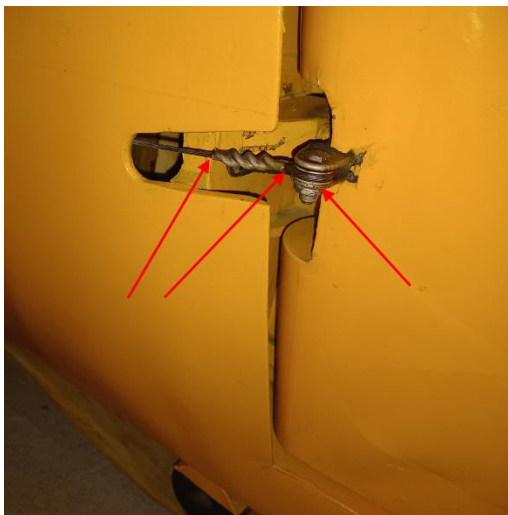
Fig. 14 – Inspection of the cable terminal eye and swaged fittings on the rudder control lever

- 4. Inspect the cable terminal eyes** at the lower attachment point of the rudder control lever, and check that the eyes do not move or rotate relative to the cables and rotate freely on the pins in the rudder control lever.
