**Subject:** Sailplane Rigging – Procedures, Inspections and Training

This SIB revises EASA SIB 2019-07 dated 30 April 2019.

All sailplanes and powered sailplanes, subject to rigging.

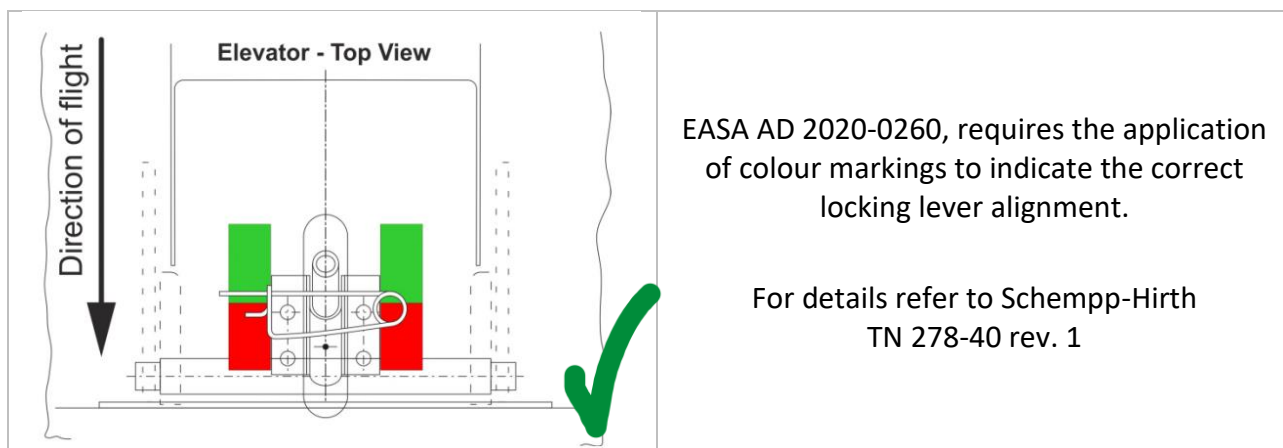
Ref.: AAIB-UK, [Bulletin 6/2020](#)

*Not all cases of unconnected controls and unconnected horizontal stabilizers can be detected by performing a positive control check. Non-interruption during the rigging procedure helps to prevent forgetting the connections in the first place. The checking of proper securing can be done by a visual inspection only.*
